# Manhole Inspection Summary

Manhole # S29Q\_\_030MH

**Location** Address: **109 West Ostend St**

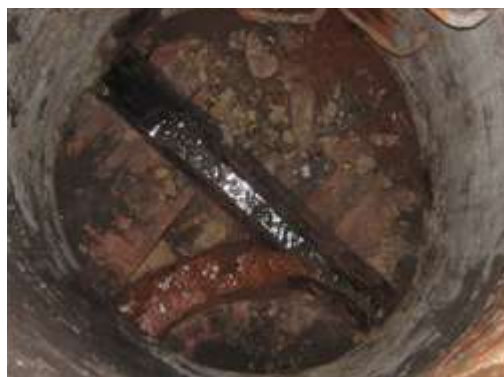
Defect 4

Condition: ☐ Sound ☐ Cracked ☐ Root Intrusion ☐ Deteriorated ☐ Leaks ☒ **Debris**

sediment and debris on bench, debris in channel

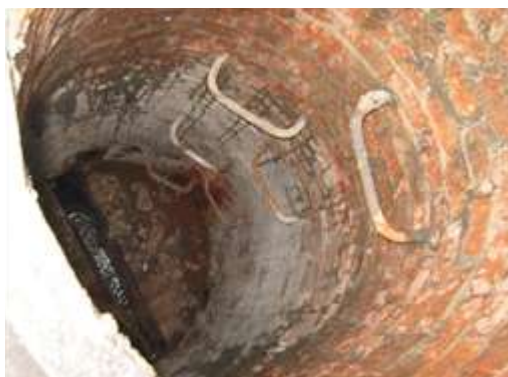
Defect 3

Count: **7** Missing: **0** ☒ **Corroded**

corroded rungs

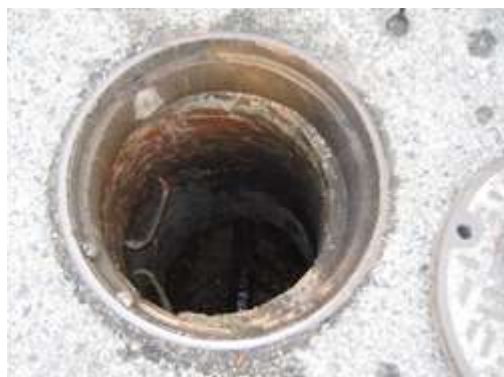
Defect 7

Condition: ☐ Sound ☐ Cracked ☒ **Leaks**

frame offset and frame leaking

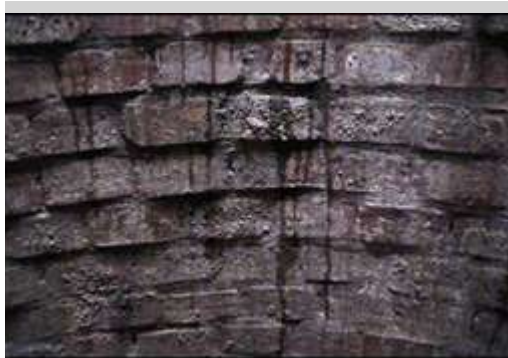
Defect 2

Infiltration: ☐ None ☐ Joint ☐ Cracks ☐ Mortar ☐ Roots ☒ **Wall**

evidence of infiltration along corbel wall

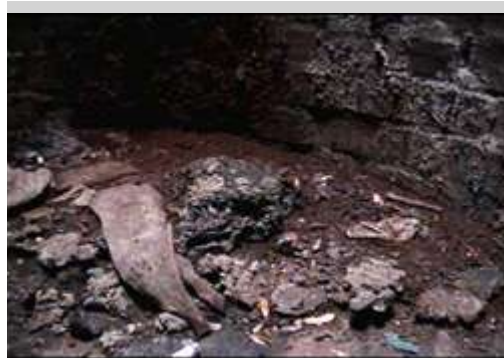
Defect 1

debris and sediment on bench

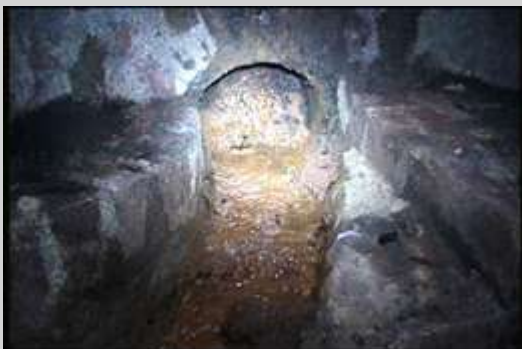
3 O'Clock Inflow

Pipe Height: **8.4** (in.) Rod and Bar (Angled)  
Pipe Material: **Clay** ☐ Pipe Lined  
Invert Depth: **11.32** (ft.) Flow Characteristics: **Slow**  
Deposits: ☐ None ☒ Mud ☐ Gravy ☒ Debris ☒ Grease  
Silt Depth: **4** (in.) Deposits Extent: **Heavy**  
Infiltration: **None** Pipe Seal Cond: **Unknown**

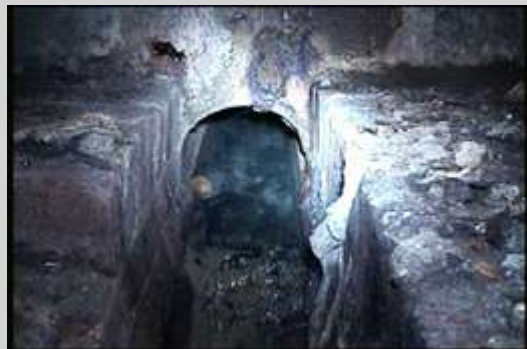
6 O'Clock Inflow

Deposits: ☐ None ☒ **Mud** ☒ **Sludge** ☒ **Debris** ☐ Grease

Silt Depth: **2** (in.) Deposits Extent: **Heavy**
